HALLS, HOUSES AND HUTS

Buildings at Ribe Viking Centre

Ribe Viking Centre & University of Southern Denmark
Esbjerg - 2014

Halls, houses and huts - buildings at Ribe Viking Centre

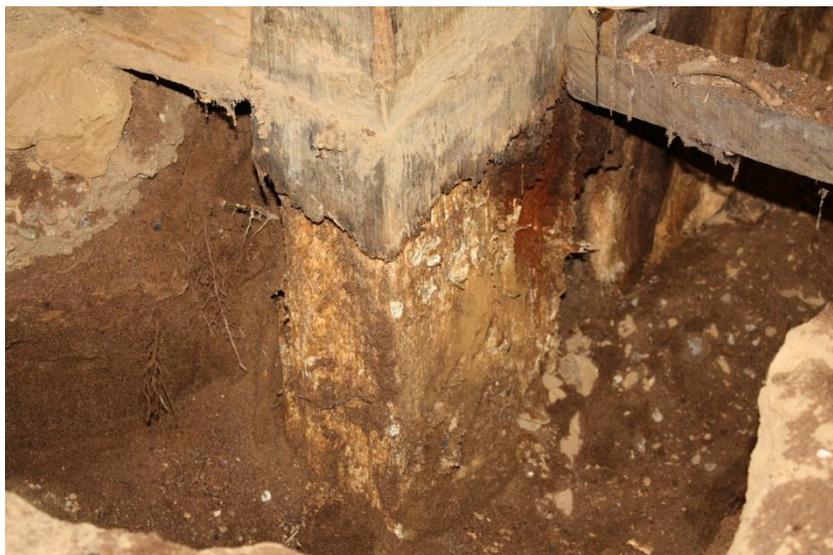
Figure 8. Deterioration of an arcade post. Up to 4 cm of material has vanished from each side, but they are still massive.

The arcade posts are dug very deep into the ground, and have seen considerable deterioration, up to 4 cm on each side. Due to their massive dimensions, there is still plenty of material left in them, and a risk assessment done in 2011 showed that they will still support the house for many years, but that gradual replacement is advisable.

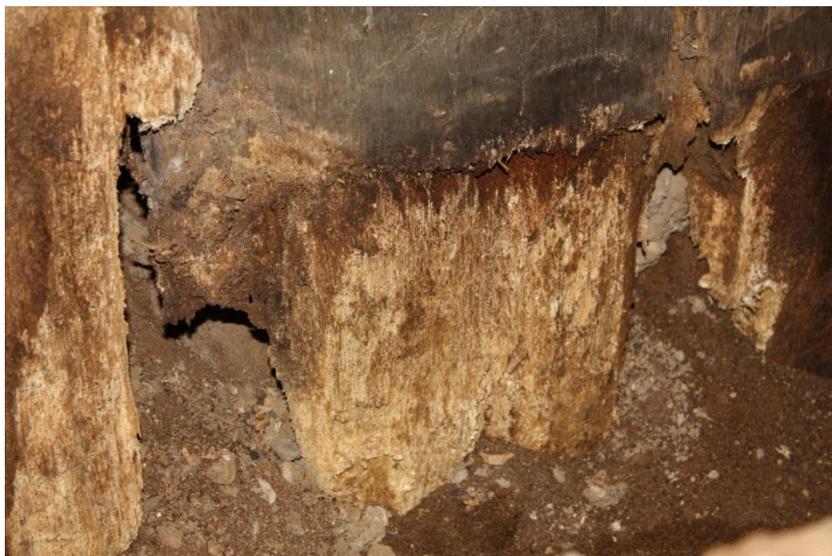
Figure 10. Deterioration of the wall planks below ground on the south side of the hall.

This weakness became very apparent when maintenance work on the house commenced in 2011. The narrower ‘tongue’ planks were deteriorated to the point where they had vanished in places. Only the thicker central part of the plank remained in the soil (Figure 10). The walls are now gradually being replaced by a sturdier type (as Figure 9, top).

Also the wall staves are gradually being replaced due to rot. As explained above, the new staves are of a different design, and the house will gradually change its appearance over the coming years.

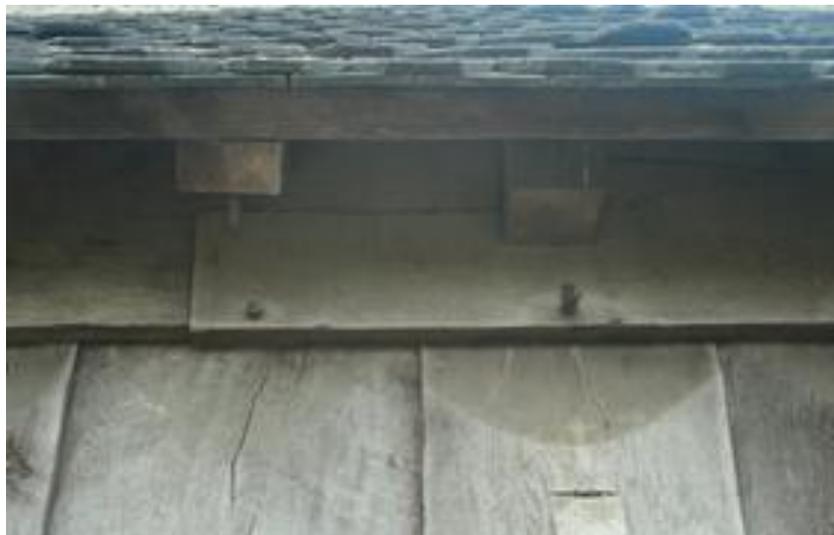
Figure 11. Wall plate scarfed and joined to staves by groove and dowel. One dowel has loosened.

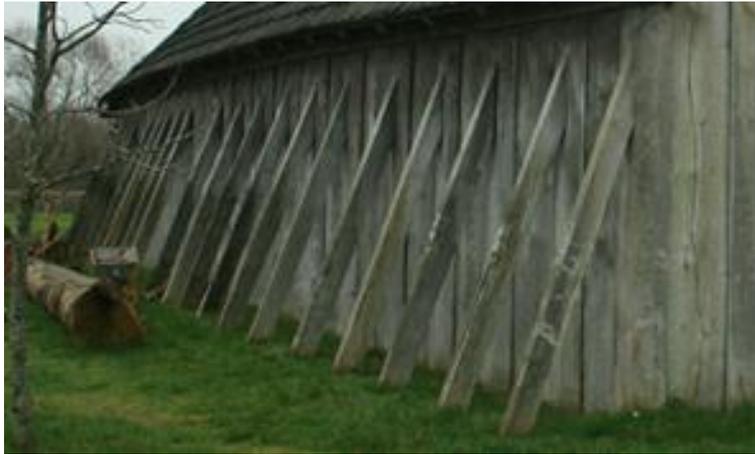
Figure 12. External buttresses

The external buttresses have more pressure placed on them now at the time of construction. Initially these external buttresses could be removed from their slots by hand but many are now held firmly in place. They are in the process of being replaced, due to rot at the ground end.

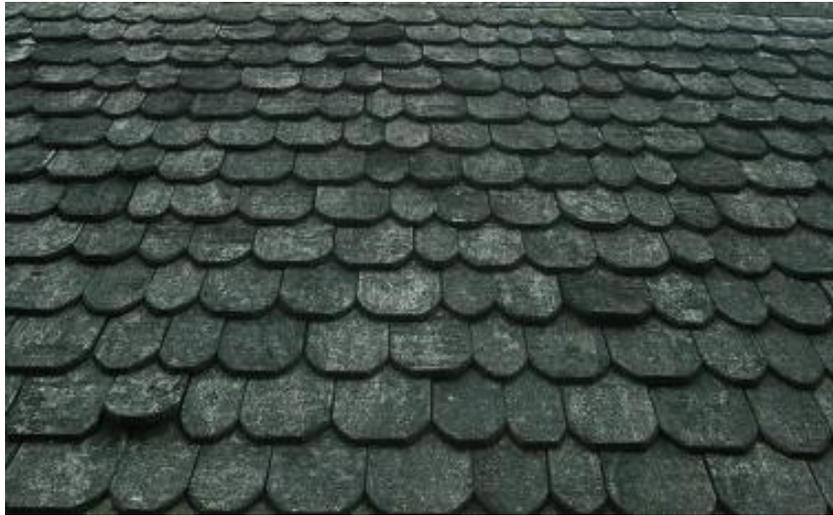
Figure 14. The shingled roof

The current problem with the shingled roof is that some of the shingles are starting to bend. This bend occurs with the shingles that have not been cut along the grain. Of the circa 5000 or so shingles about 400 were entirely shaped with an axe and were therefore cut with the grain of the wood. As for the other shingles, they were cut with a saw; this causes bending and warping over time. Although some shingles were cut with a saw and others with an axe, the exposed side of all the shingles was finished with an axe to give a more traditional look to the roof. It is only by looking closely on the underside of the shingles that one could distinguish between those cut with an axe and those cut with a saw.

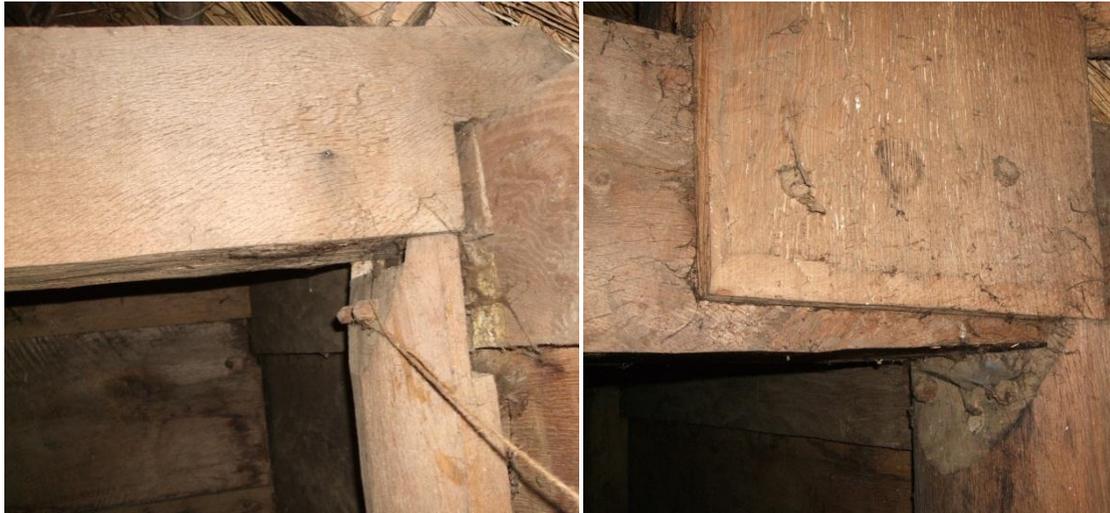
Figure 23. Left: The fastening of the collar tie, inner support and wall plate at N3, being the original fastening as devised by the architect. Right: The repair at N5, where the somewhat frail construction has been covered by a wooden “box”.

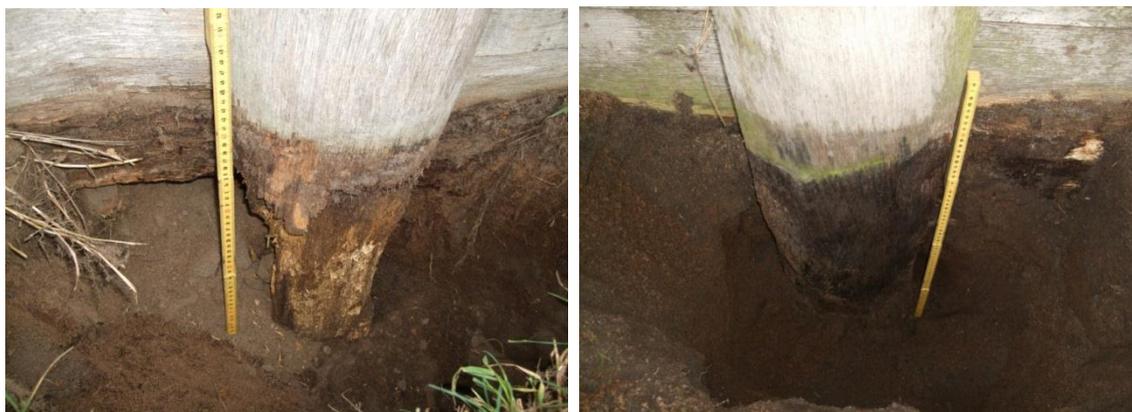
Figure 27. The post S3 was one of the most worn posts of all on the Bole House. The contrast of the wear on the northern side of the house (here post N3) was striking in some cases.

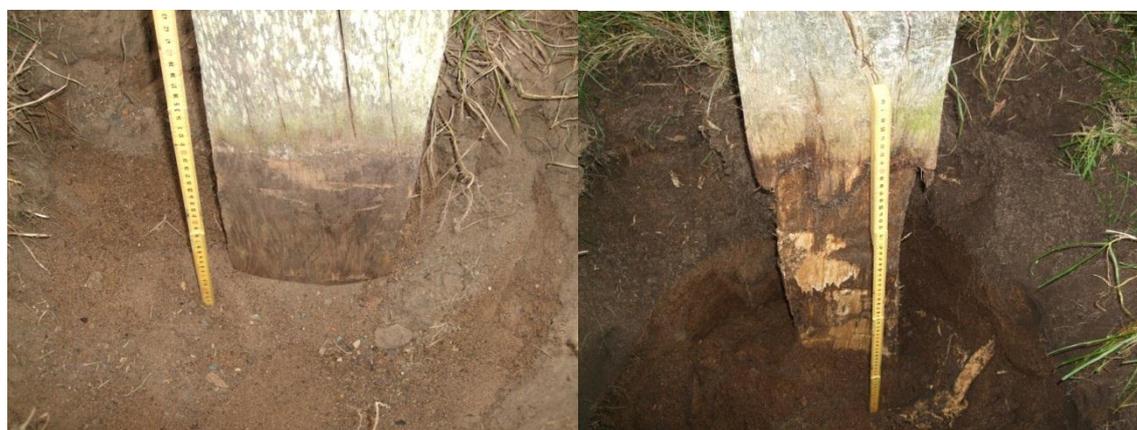
Figure 28. The difference in wear of the western (left) and eastern (right) posts. Though the western post's pit is dug deeper in these pictures, the difference in the soil is clearly visible, with the eastern hole being significantly moister.

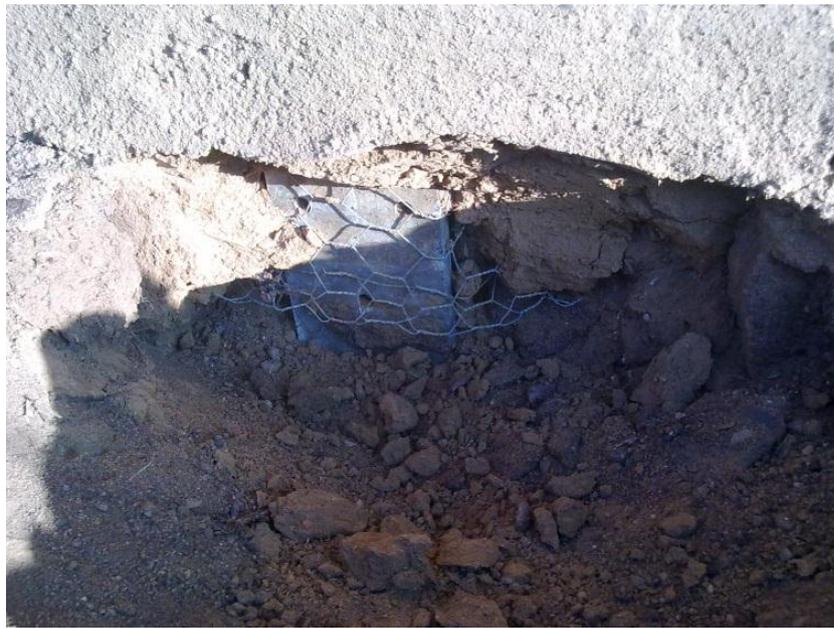
Figure 39. Showing iron plate attached to newly cut wooden stave at one end and inserted into concrete at the other.

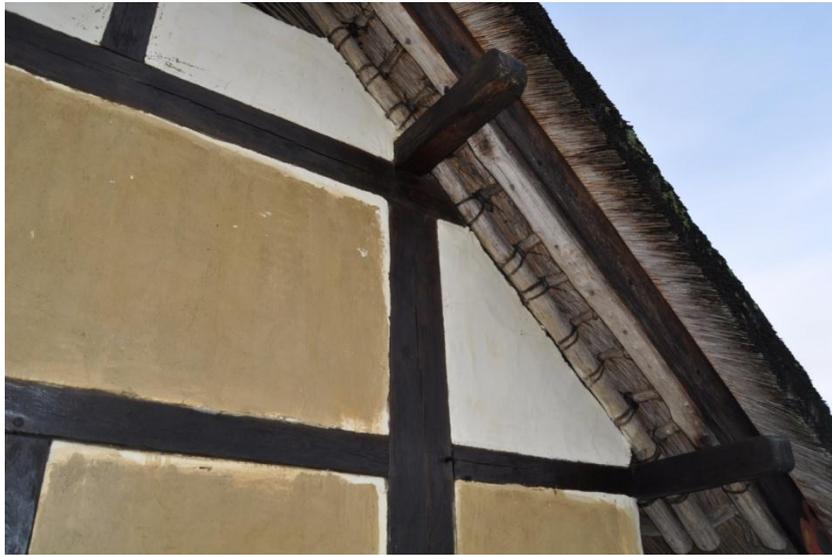
Figure 54. Repairing of the clay wall. Fresh clay can be seen as khaki patches against the white walls.

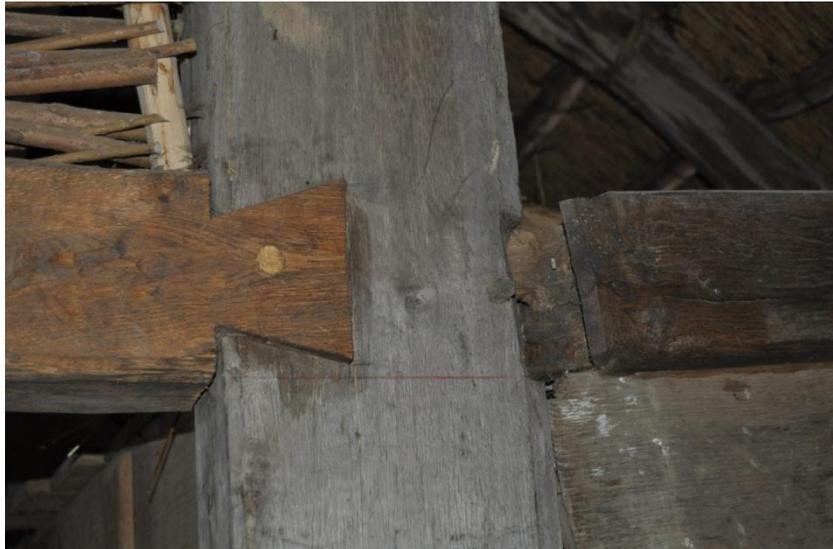
Figure 55. Damaged joint The outward force of the wall has pushed the beam out of place.

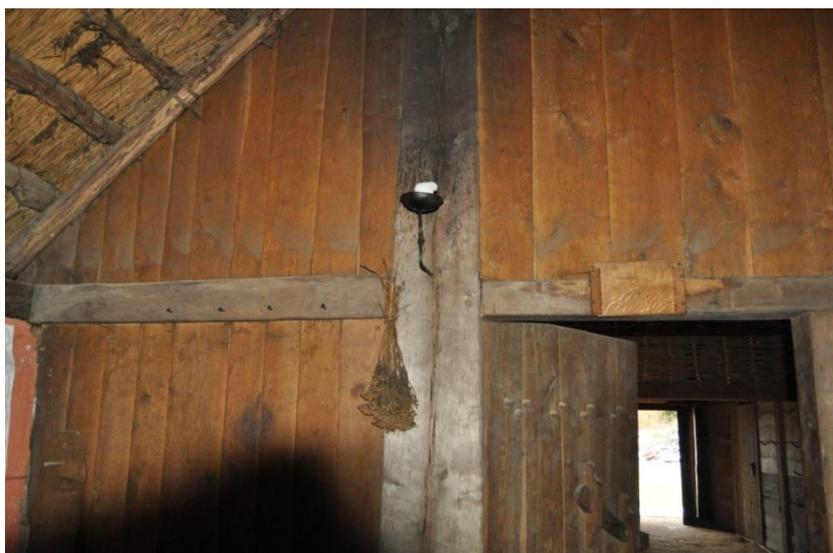
Figure 56. Dividing stave wall: treenails locking staves and deformity of staves visible.

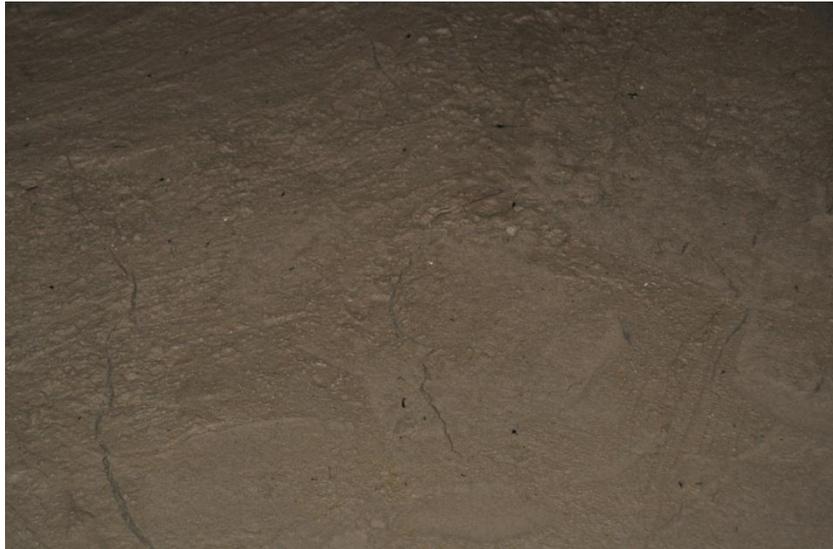
Figure 64. A clay floor in the process of drying, cracks begin to appear as the floor dries.

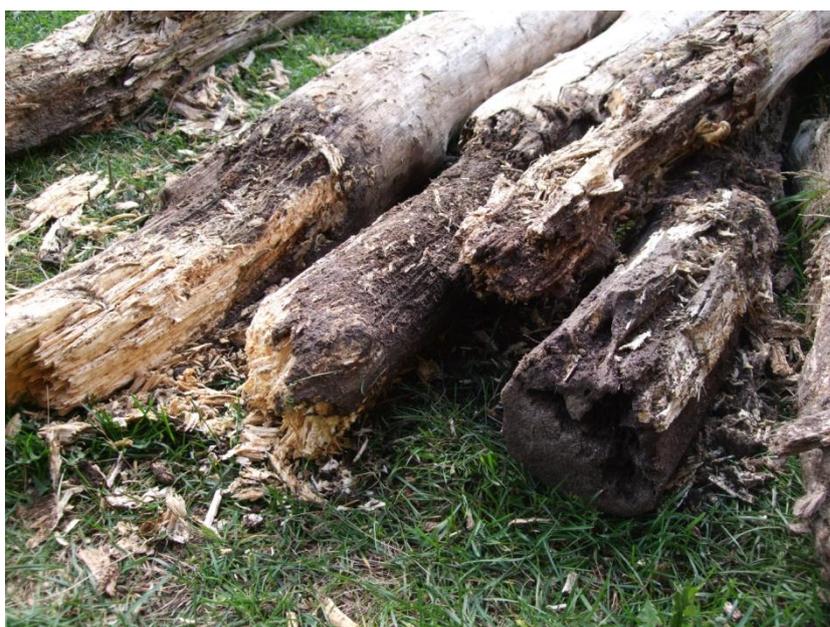
Figure 72. External buttresses removed from house A and B, underground parts. These were among the most damaged of the lot.

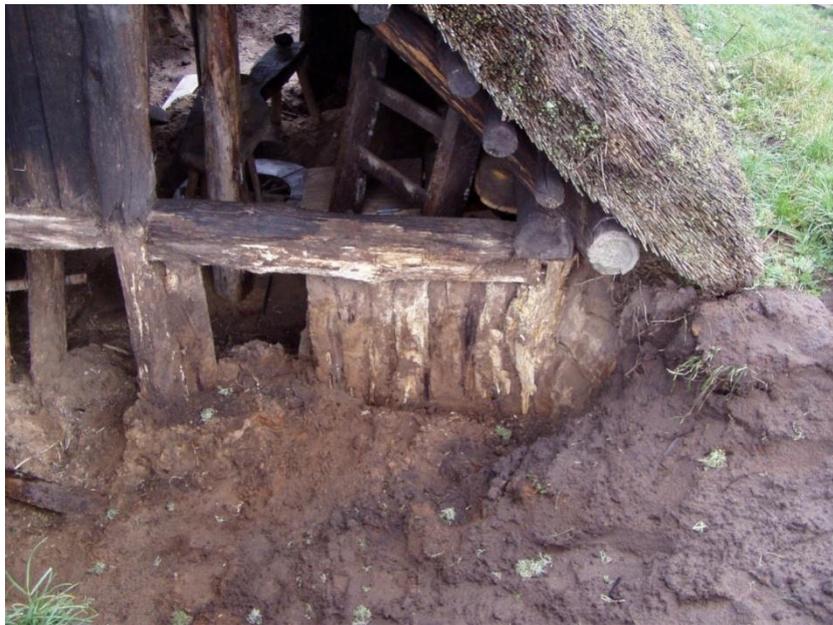
Figure 78. The stave wall of the Potter's hut during replacement, 2011. The pottery wheel can be seen inside the house.

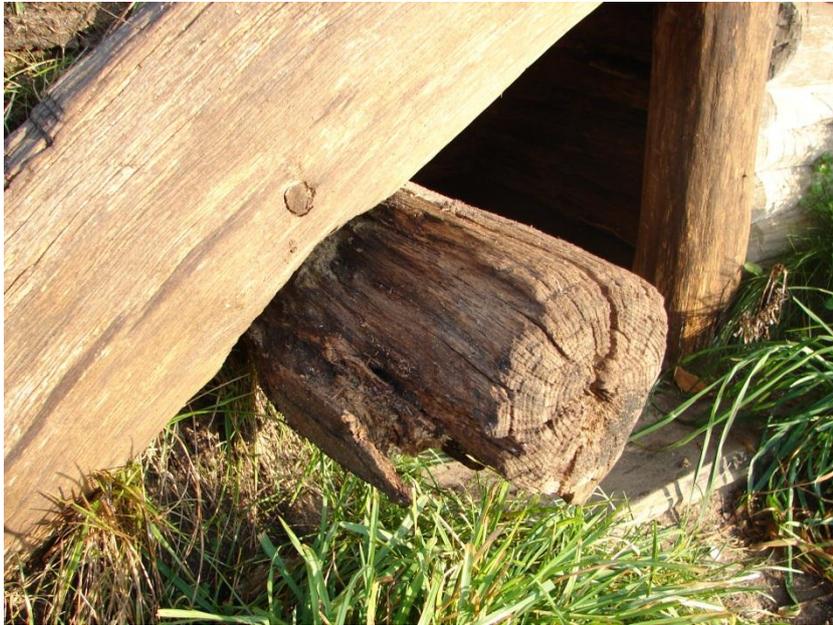
Figure 83. The protruding wall plate of the small sunken hut in Ribe Town. More or less an unworked pole, the sapwood has largely disappeared over the years. This house is now dismantled and replaced.
