HALLS, HOUSES AND HUTS

Buildings at Ribe Viking Centre

Ribe Viking Centre & University of Southern Denmark
Esbjerg - 2014

Halls, houses and huts - buildings at Ribe Viking Centre

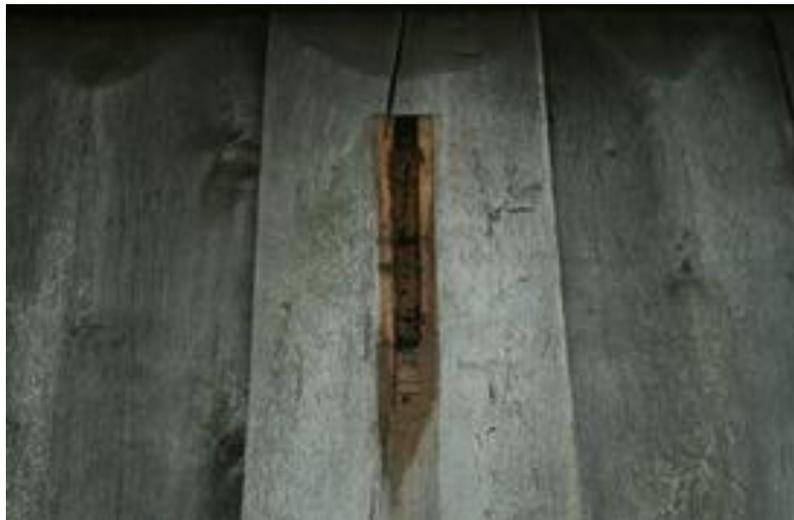
into prepared slots found up high on the actual staves (Figure 13), and do not make contact with the wall plate. This was the design of the architect, who had recently reconstructed a similar house at Fyrkat, although with the buttresses supporting the wall plate directly. Apparently he wanted to experiment with the design. Having the external buttresses placed in this position is not nearly as effective as having them butted up against the wall plate, and in effect they are more there for aesthetics than for increasing the structural integrity of the building. When the long house was first built the external buttresses could be easily pulled out of their slots by hand but with time the weight of the roof has put them under more pressure and many of them are now held more firmly in place, while others are still very loose.

Figure 13. External buttress slot. This buttress could easily be removed, so has no structural function in the building.

The external buttresses have more pressure placed on them now at the time of construction. Initially these external buttresses could be removed from their slots by hand but many are now held firmly in place. They are in the process of being replaced, due to rot at the ground end.

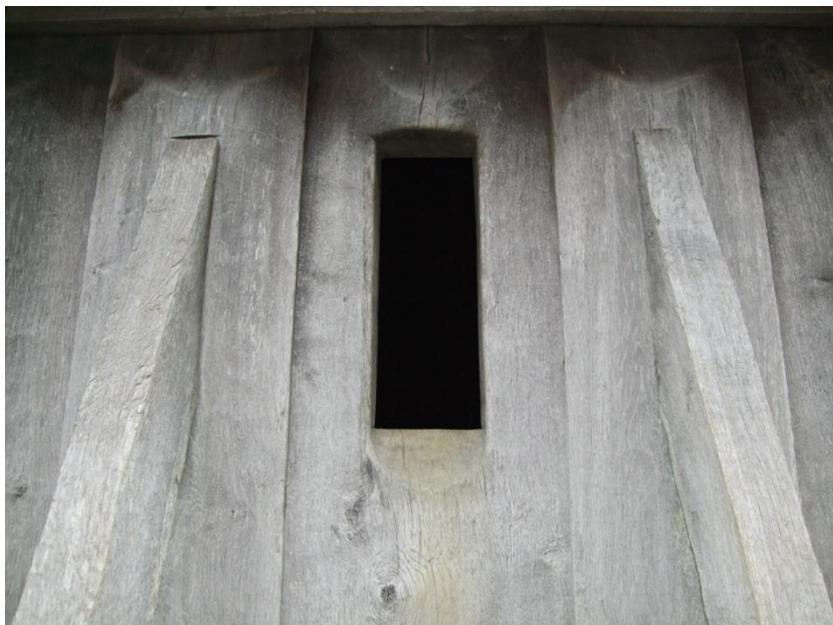
Another important alteration was the installation of windows (Figure 18). The house itself was too dark to work in and so decision to cut out small section from some of the staves was made. Cut through the staves in the finished house, the windows are high and narrow, and of similar but not exactly same dimensions. A salvaged wattled gable from Hedeby has a window 32×48 cm and it is assumed that houses during this period had small windows that were widely spaced from one another making the inside of the houses quite dim.

Figure 18. One of the windows on the south facing wall. The opening can be closed with a plate.

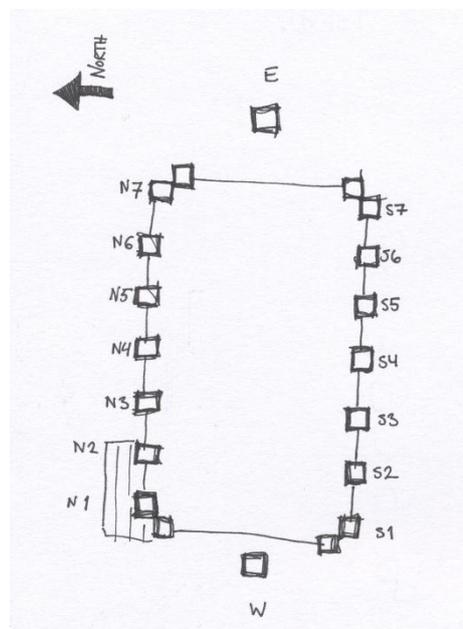
Figure 22. Field sketch of the Bole House and the reference numbers used in this text. Not to scale.

When digging sampling holes around the wall posts, it became evident that there was a noticeable difference between the south and the north side. The north and east posts have all been better preserved than the south and west posts (Figure 27). The western post has a more "expected" form of decay, placed just at the surface of the ground, but the deteriorated part stops a few decimetres down and the shape become fuller again (in contrast to the pointy wear in the Hall, and even on post S3). The eastern post has no wear at all. It was very solid, which is strange as the sample showed very dry soil. The sandy soil of the sample may well have been left over from the top soil, but the sample was not taken noticeably higher than the other samples, so there may be a difference at the depth of the sandy soil as well. There may also have been some contamination of the sample in sand falling down from the uppermost layer.

No samples were taken from the posts N1 and N2 due to the door construction being in the way (cf. figure 22). That being so, there will be no direct linear reference to the difference of the posts S1 and S2, which is why we let S1 be still. The results speak clearly enough, however, that there is a difference in the soil moisture and that has influenced the wear of the posts. With this in mind, there are questions to be asked in consideration of the soil type the Viking Age people would prefer. The Ribe Viking Centre used to be wetlands, but now there is a 1.20 m layer of

To replace some of the outer support posts will soon be necessary in the bole house. This became obvious when we dug holes around most of the posts to look at the deterioration, which will be further described towards the end of this chapter. The posts on the south side are much worse off than the posts on the northern side of the house, so the south side should be the starting point. Luckily the construction makes for easy replacement. One of the posts is taken out; they are only fastened with two treenails in the wall plate, so it should be easily done. The bottom plank could also be replaced quite easily by just being taken out from underneath. Then a new support post is put in place to replace the old. The eastern roof bearing post is almost as good as new, but the western should be looked into. It has still much bearing wood left, but seems to deteriorate faster than its eastern counterpart. It will not be as easily replaced as the other posts, however, and the question for the Centre is of course whether there will be a 'Viking' way to replace it? One should not neglect the value of being able to do such tasks during the tourist season. Otherwise maintenance with more modern equipment must be undertaken off-season.

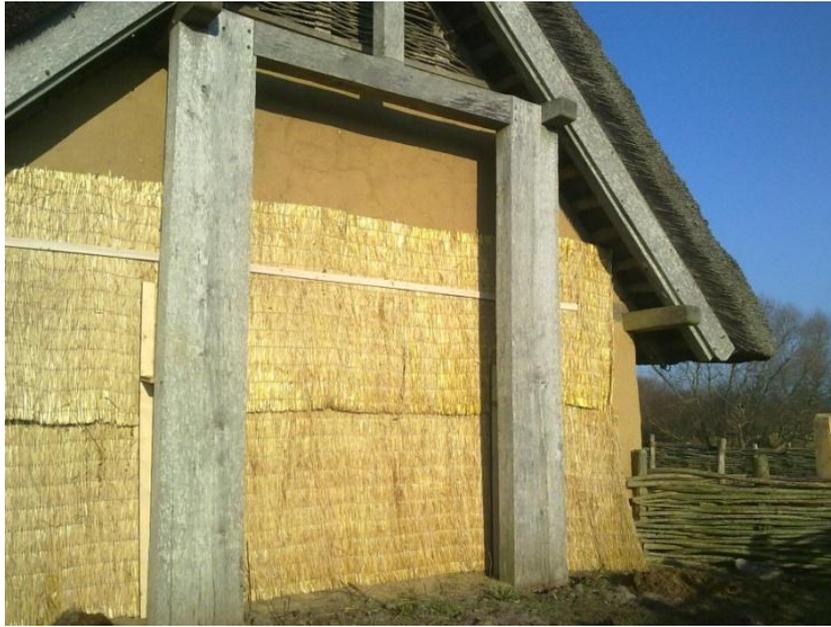
The two gabled walls are more exposed to the wind, sun and rain making them subject to re-daubing whenever wear becomes evident. Another method of protecting the exposed gables can be seen on the south facing gable where a straw mat has been placed right across the wall (Figure 32). All the outer walls in the byre are kept out of direct contact from the cows. The east facing wall also has a fence put up so that the livestock cannot make contact with in whilst outside and the north facing gable has vertical wooden staves that serve the same purpose.

Figure 32. Straw matt used to protect the gabled walls against the elements.

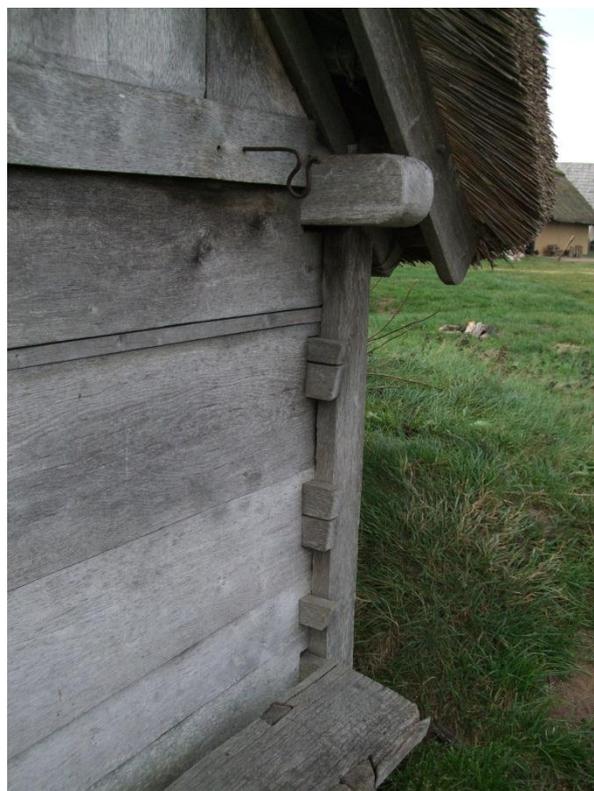
The bole construction consists of five planks on the western and southern wall, while the northern wall has four planks. On the eastern wall there are some narrower planks, along with one very narrow plank that seems to be a repair, which makes the total number of planks seven. The gables have the stave construction on top, like the Bole House, but unlike the other houses, the smithy lacks the wattle opening at the very top of the wall. The stave construction has 14 staves on each side. The eastern wall also has the door, which is accompanied by one stave next to the door posts.

Figure 43. The eastern wall with the tenons protruding from the northern wall's bole planks. The picture also shows the narrow plank (second plank from above) put in after the shrinkage of the wood gave a large opening between the planks. The grass embankment surrounding the Smithy can also be discerned behind the house.

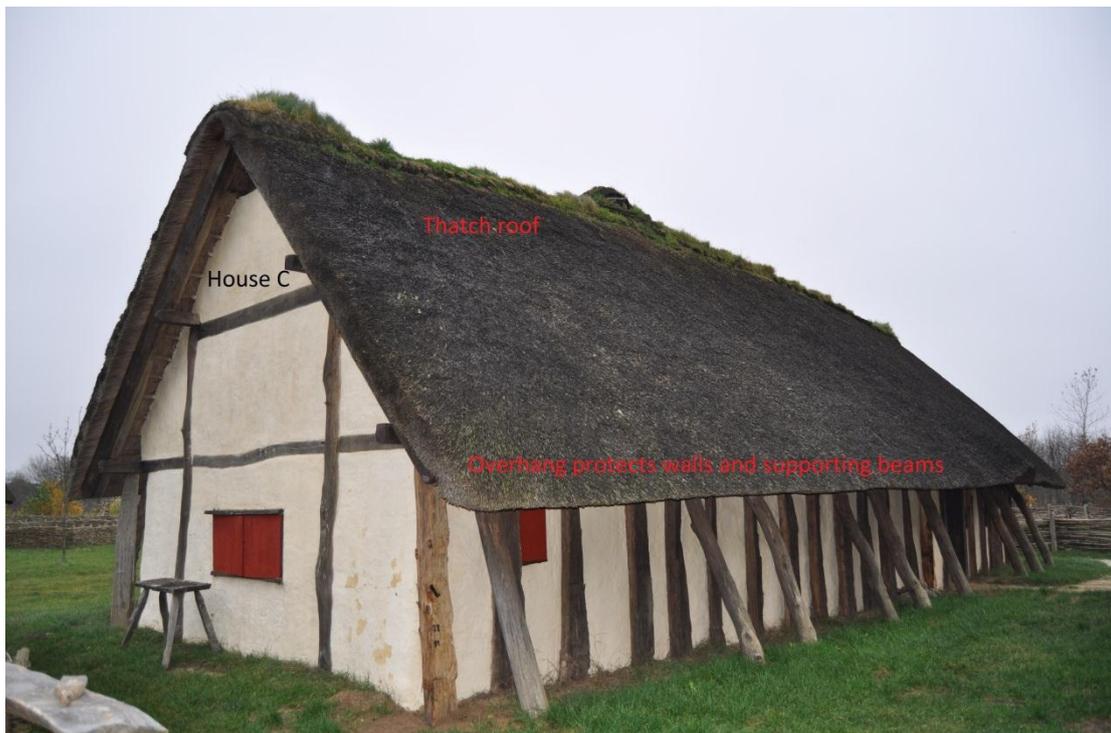
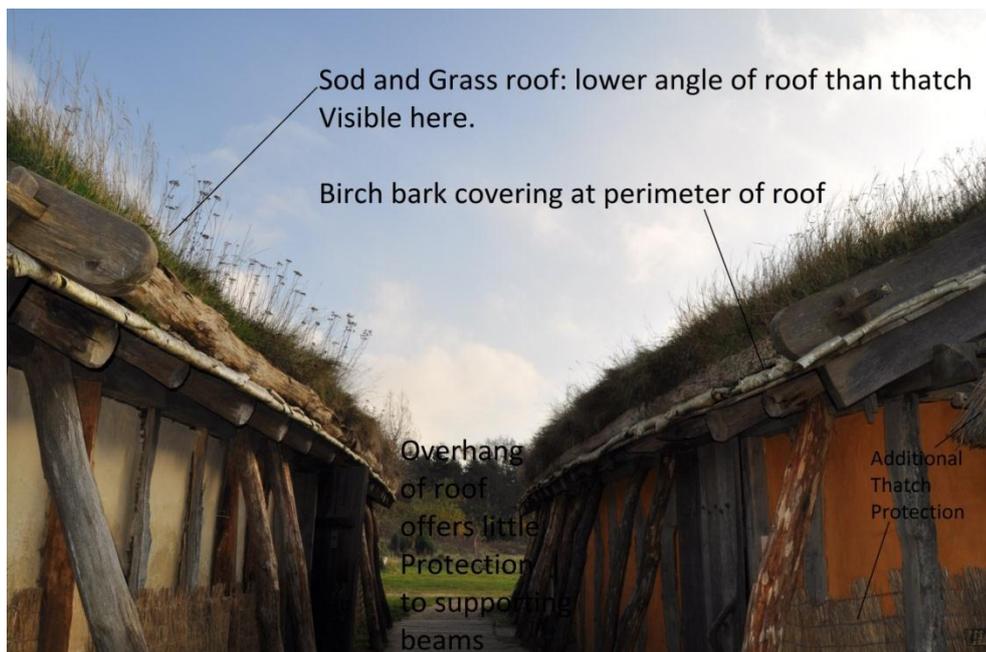
Figure 70. The roof types of the Ribe houses. Above: House C, below: House A and B.

There were no traces of the roof construction style found at the excavation site on *Tvedgade* and therefore two different roof styles were adapted at the Ribe Viking Centre. Houses A & B are sod and grass with birch as a lower covering. House C is a thatch roof. The grass roof needs a minimum angle of 20 degree whilst the thatch roof requires a minimum angle of 40 degree. It is felt by the staff that the thatch roof works better than the grass roof (Figure 70).

The overhang distance of the roof has helped to protect the supporting buttresses and walls of house C. The lack of an overhang of the roof on house B has led to wall and buttresses damage due to rain. Therefore in houses A & B thatch protection was added to the upper parts of the gable walls and thatch sheeting was placed around the base of the walls of house A & B (Figure 69). This is an indication of how a greater overhang of the roof functioned in the most utilitarian manner and is presumably in indication for roof style in the Viking age.

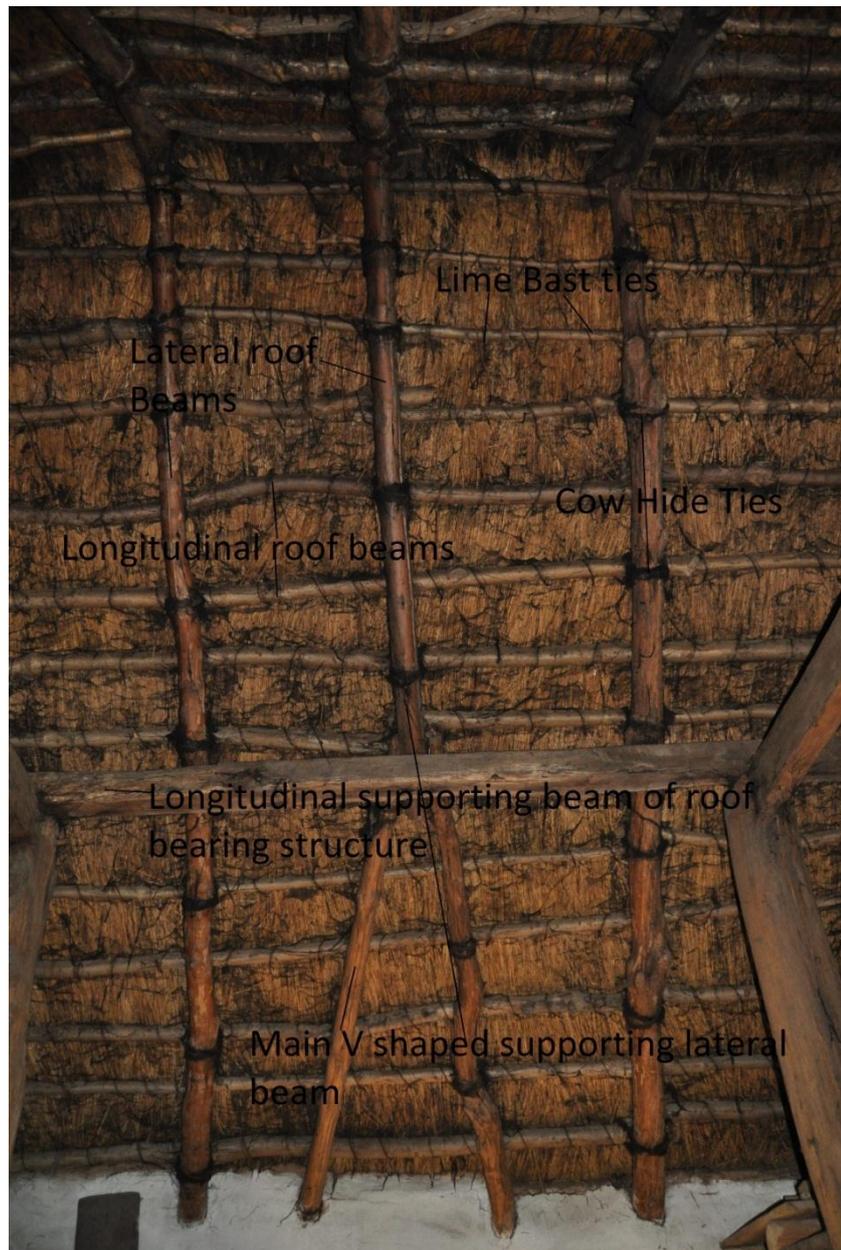
The thatch roof of house C follows the norm of the roof types in Ribe Viking Centre. The thatch is either wheat or rye. In house C cow hide is used for fastening of the thatch to the beams and to each other. Lime bast is used for the rope which attaches the thatch to the longitudinal beams. Each side of the roof in house C has a V shaped lateral beam which is composed of three elements, two run diagonal to meet a central beam. This is located above the door on both sides of the house. It adds strength to the roof and disperses the weight evenly. One of the lateral posts on one side terminates in a V shape to accept the beam of the other side. These are all

Figure 71. Thatch roofing, House C.

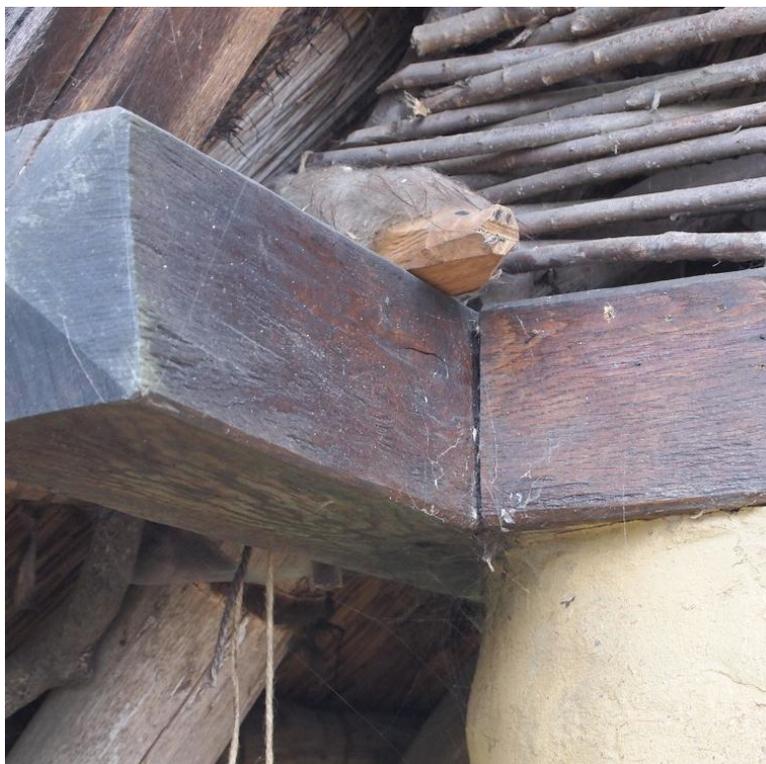
Following the discussion on the importance of eaves above, we have also noticed that although the houses generally have wide eaves to protect the sides of the houses, the horizontal timbers of the roof construction protrude very far out from the gables. As a result, they are constantly wet, the wood being dark and slippery. This is probably not a good idea either, and when being asked, the builders had no explanation for it. It just seemed natural during construction.

Figure 73. The wall plate of the wood working shop. All horizontal posts in the roofs extend very far beyond the roof.

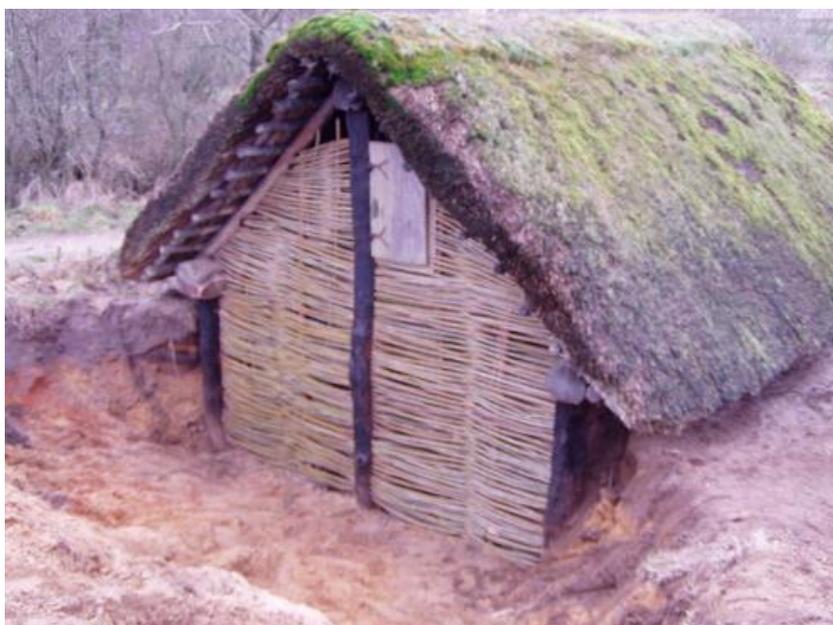
The hut originally started with only wattle walls, and only later it was decided to cover the wattle with clay. In terms of maintenance, these walls are apparently the least demanding of the three. They are also considered to give the best weather protection, although it must be remembered that this house is heated, due to its use as a smithy. Nonetheless, the impression of the artisans at Ribe Viking Centre, is that the wattle and daub walls are superior to the other two types.

Figure 80. The Smithy during an earlier reconstruction of the walls. Even the underground parts can be seen.

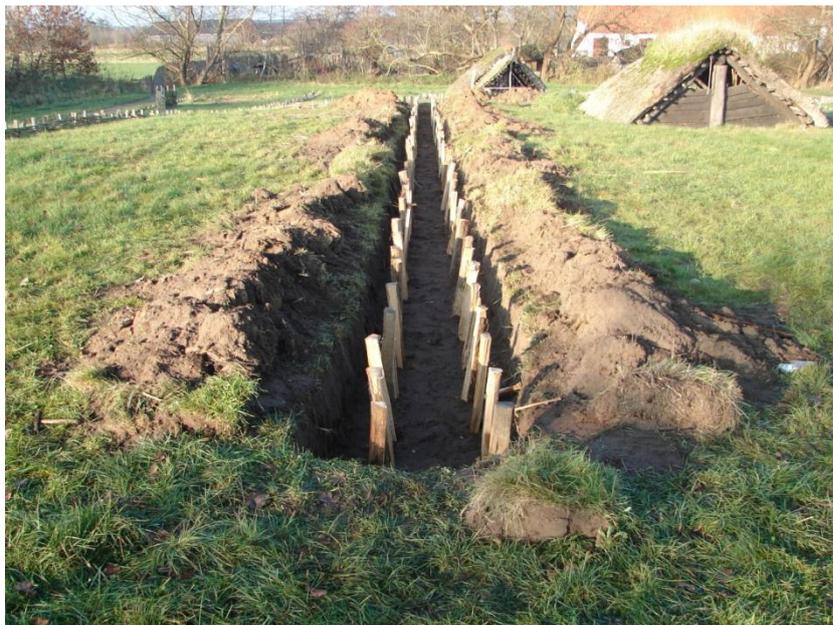
Figure 82. Replacing the wattle surrounding the plots at the Market Place.
